## SERVICE BULLETIN No. 324

B' AND 'C' RANGE PUSH ROD COVER TUBE OILING SEALING (1969/1970) MODELS)

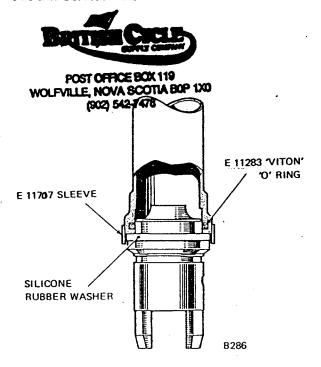
A simple but effective 'Service Fix' has been devised to eliminate any push rod cover tube oil leakage. This applies to machines fitted with the following components as used on 1969/1970 production, i.e., after engine number:—

Remove the push rod cover tubes, and check the upper and lower flanges for squareness by rolling on a flat surface. Position a cadmium-plated sleeve, part number E 117d7 over the lower end of each cover tube. In most cases the sleeve will be a tight fit, but if necessary a proprietary bonding agent can be used to secure it. (See diagram for correct positioning of sleeves).

An additional sealing washer should be fitted over each tappet guide block to prevent leakage. The purpose of the sleeve is to control any tendency for the washers to 'squeeze out' when the cylinder head is tightened down.

Use the latest type of 'Viton' (black rubber) 'O' ring seals, part number E 11283. Position one seal in the recess at the lower end of each cover tube, and one in each recess in the cylinder head.

Fit the head gasket and position the cylinder head on the block. Press the head downwards to ensure that the seals are seated correctly. Before tightening the cylinder head bolts measure the clearance between the head and gasket. This must be between 0.030–0.040". If the clearance is not correct, adjust the thickness of the white silicone rubbers accordingly.
